Zn Bath Corrosion Behavior of the Martensitic Stainless Steels (1.4095-Type) After Variation of the Si and Cr Content in Comparison to the Ferrite-Free 316L Type (1.4409.01)

The martensitic cast steel 1.4095 shows a good corrosion resistance in liquid Zn-bath in a temperature range up to $T = 480^{\circ}\text{C}$. In this study, the chemical composition of the 1.4095 material has been modified with respect to Si and Cr content. These modified alloys will be subjected to a static liquid corrosion test in a Zn-bath for different test durations and test temperatures. Additionally, the mechanical properties will be presented. The results are compared with the corrosion results of the ferrite-free modified 316L. Afterwards the tested samples are evaluated by means of mass loss, optical microscopy and scanning electron microscopy.

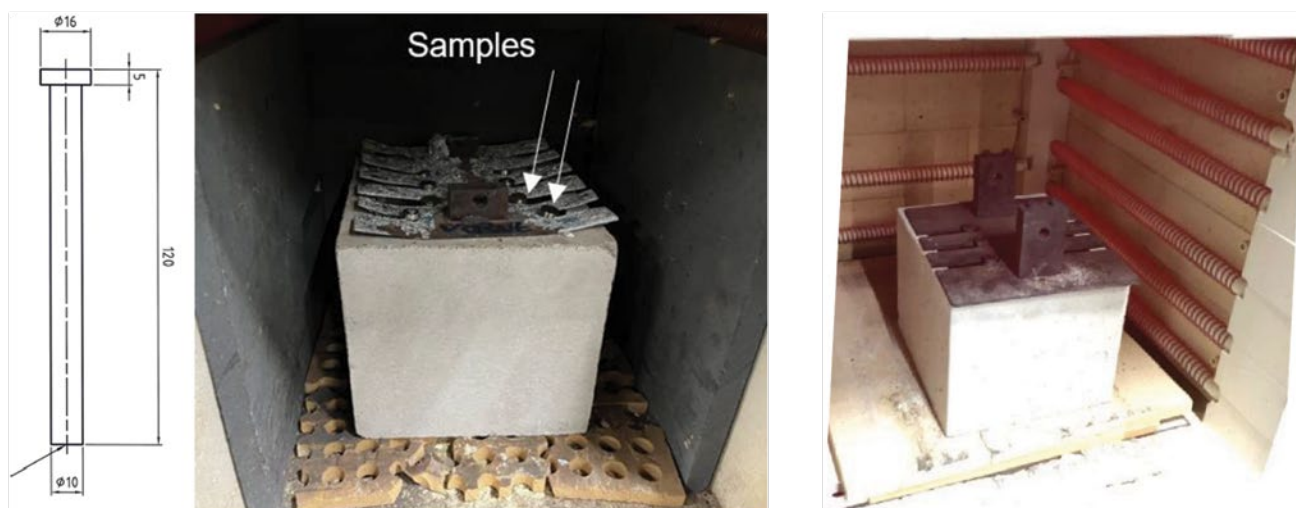
Figure 1

The drawing of the test sample is shown on the left side. In the middle a live test can be seen – white arrows are showing on the top of the samples. On the right side, the test rig for the corrosion experiments in the heat treatment furnace is shown prior to a test.

The static corrosion test in the liquid Zn bath was performed in a self-constructed test rig consisting of a crucible in an electric-heated furnace. For these tests, a sample holder exists which can take up to 10 different samples at the same time for the static corrosion test. This has the advantage that 10 samples can be exposed to the corrosive bath at the same time and a high throughput with respect to the number of alloys/batches tested is possible. This experimental setup is flexible with respect to test duration and test temperature.

Fig. 1 also shows a drawing of the sample geometry used and the setup of the test rig. The crucible shown in the middle and right pictures contains the liquid Zn bath and the corrosion samples are statically immersed in the Zn bath for the duration of the test at the designated test temperature. The parameters for the corrosion tests in this study can be found in Table 2. In the first experiment, a long-term static corrosion test was conducted for 715 hours (~30 days) at a temperature of $T = 480^{\circ}\text{C}$. The second test was conducted at a temperature of $T = 500^{\circ}\text{C}$ but the test was canceled only after a test period of only 100 hours due to a failure of the test rig. More details of the rig failure will be discussed later.

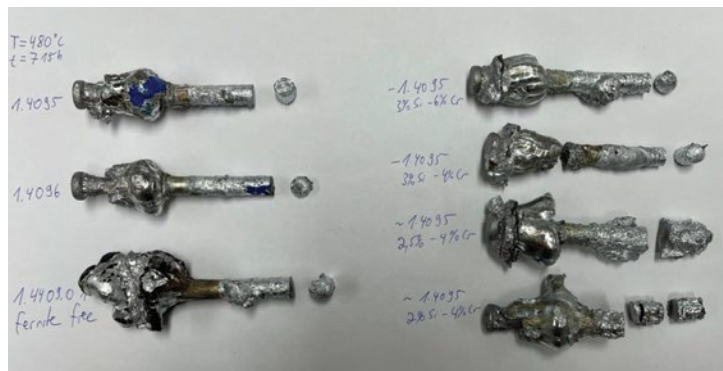
Figure 4

Macroscopic results of the corrosion test at $T = 480^{\circ}\text{C}$ for 715 hours is presented. All samples have a massive Zn layer around each sample on the upper part of the sample. The lowest parts of the sample are already cut off the samples for the microscopy.

After 715 hours in the Zn bath at a temperature of $T = 480^{\circ}\text{C}$, the samples were removed out of the test rig and in the first step compared macroscopically. The macroscopic picture of these samples can be found in Fig. 4. On the left side, the 1.4095, 1.4096 and the ferrite-free 1.4409.01 material can be seen. On the right side, the different samples with the variation of the Cr and Si content are presented. The samples on the right side were brittle so that some samples were torn up during removal from the test rig.

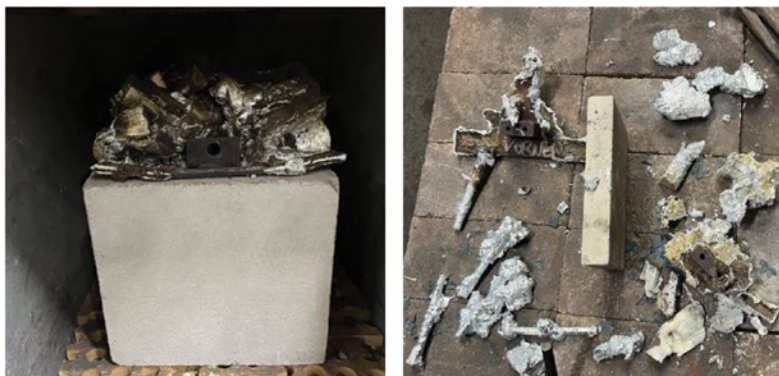
Figure 5

The left side shows the test rig in the furnace prior to the end of the test at $T = 500^{\circ}\text{C}$ after a duration of 100 hours, and the right side shows the buildup of Zn on the sample holder after several hours.

After the test at 500°C , it was visible that a huge amount of buildup of Zn originated on the sample holder after several hours only (see Fig. 5 right side as a reference). The amount of built-up Zn increased continuously, so that the experiment was canceled after 100 hours (the plan was also a test duration of around 700 hours). During removal, the sample holder broke and some samples were lost. The samples caught were afterwards analyzed via OES so that the traceability was ensured.

A huge amount of built-up Zn can be found on the sample holder. During the removal of the sample holder from the test rig, the complete sample holder was broken, and the samples were caught out of the bath (if possible). The individual samples were then identified via OES since there was no traceability possible anymore. On the right side of Fig. 5, the remains of the sample holder and some caught samples are presented.

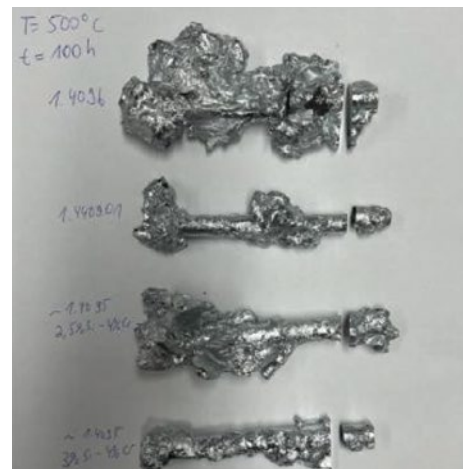
Figure 6

Macroscopic results of the corrosion test at $T = 500^{\circ}\text{C}$ for 100 hours.

The samples that survived the test at $T = 500^{\circ}\text{C}$ for 100 hours are presented in Fig. 6.

The 1.4096 and 2.5%Si-4%Cr sample exhibit large Zn layer buildups. This can be an artifact from the removal of the samples out of the Zn pot. There is already a small piece cut off for the OES analysis and the microsection.

All samples have a Zn layer around each sample on the upper part of the sample. The lowest parts of the sample are already cut off the samples for the microscopy. Only four from the seven samples could be caught after the breakdown of the test rig.

The other three tested samples were lost during the extraction of the sample holder after the test.

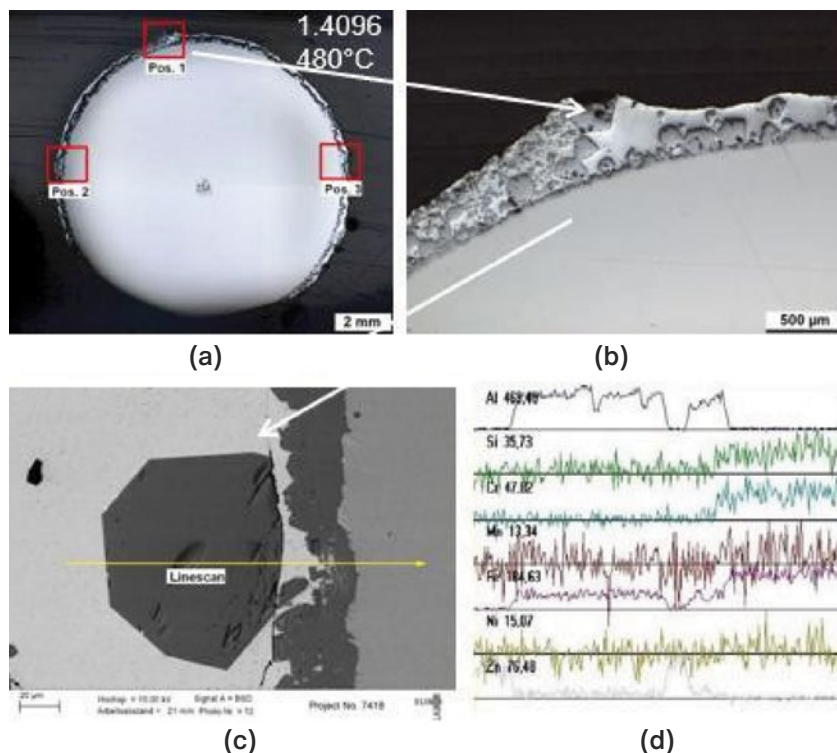
Figure 9

Optical microscopy and scanning electron microscopy (SEM)/energy-dispersive x-ray spectroscopy (EDX) results from the corrosion test at $T = 480^{\circ}\text{C}$ for 715 hours are shown for the 1.4096. (a) and (b) present results from the optical microscopy.

The Pos. 1 in (a) is the enlarged position I (b). (c) shows a detail of (b) at a higher magnification in the SEM. The arrow in (c) refers to the EDX line scan in (d) for different chemical elements. The elements Al, Si, Cr, Mn, Fe, Ni and Zn were analyzed.

Fig. 9 and Fig. 10 present the SEM and EDX line scan result from the 1.4096 material after the static corrosion test at $T=480^{\circ}\text{C}$, 715 hours (Fig. 9) and the test at $T = 500^{\circ}\text{C}$ for 100 hours (Fig. 10). The structure of the images is identical for both experiments. Images (a) and (b) reveal the light microscope images of the sample for an overview (a) and an enlarged area (b). Image (c) is a magnified SEM image of (b). The arrow in image (c) marks the course of the EDX spectra in (d). The quantitative analyses of the elements Al, Si, Cr, Mn, Fe, Ni and Zn are presented one below the other. The line scan in Fig. 9 shows, e.g., for the element Al, no signal at the starting point. When the analysis arrives the

dark blocky inclusion in (c), a strong increase in the Al signal is present. Between the particle and the layer around the sample, the Al signal drops back to zero. In the base material, the signal for Al is at zero. For the element Zn in (d) in Fig. 9, an opposite effect of the Zn line scan signal is obvious. The signal starts with a high-level signal and drops down to almost zero when the dark blocky particle is analyzed. Between both darker regions, the Zn signal goes up again. The course of the Fe analysis line corresponds to that of the Al analysis line with the difference that the Fe line is high in the base material. A detailed analysis of the EDX result of the corrosion test at $T = 500^{\circ}\text{C}$ and 100-hour duration (Fig. 10) shows the darker precipitate and the darker thin layer have the same tendency with respect to the signals of Al, Zn and Fe. The sample has a corrosion layer with a Zn-rich chemical analysis. In this layer, particles/precipitates are embedded with an increased Al and Fe content. Most likely the analyzed samples of the 1.4096 material have an Al and Fe-rich thin layer around the sample for both test parameters used in this study.
